The existence of coastal forest, its implication for tsunami hazard protection, a case study: in Cilacap-Central Java, Indonesia

Yudhicara

Geological Agency

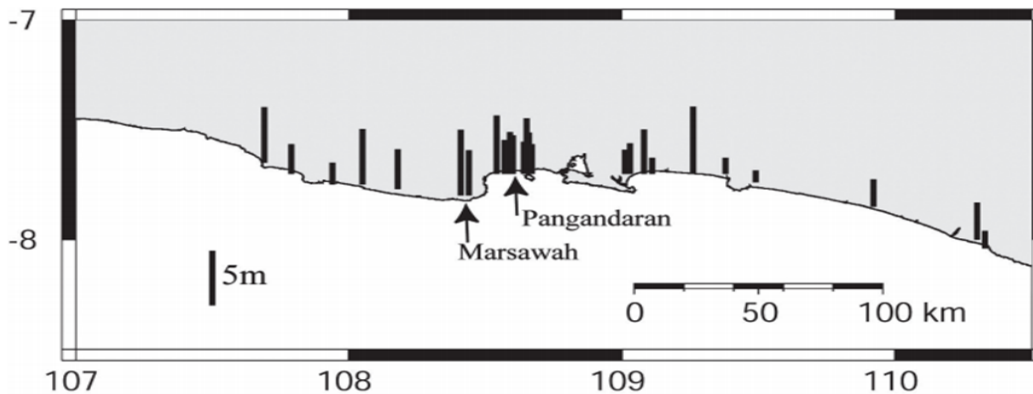
Figure 3. Tsunami run-up heights of 7.7 was measured by Kongko et al. (2006) and Ministry of Marine Affairs and Fisheries et al. (2006) in Mori et al., 2007

According to Mori et al. (2007) the tsunami run up reach up to 7.7 m height (Figure 3) at Selok, with velocity of 256 km/hr, 3 waves come inland and the second was the highest. Inundation distance was ~500 m caused 18 deaths and one family saved by the 2 m palm tree (survivor testimony).

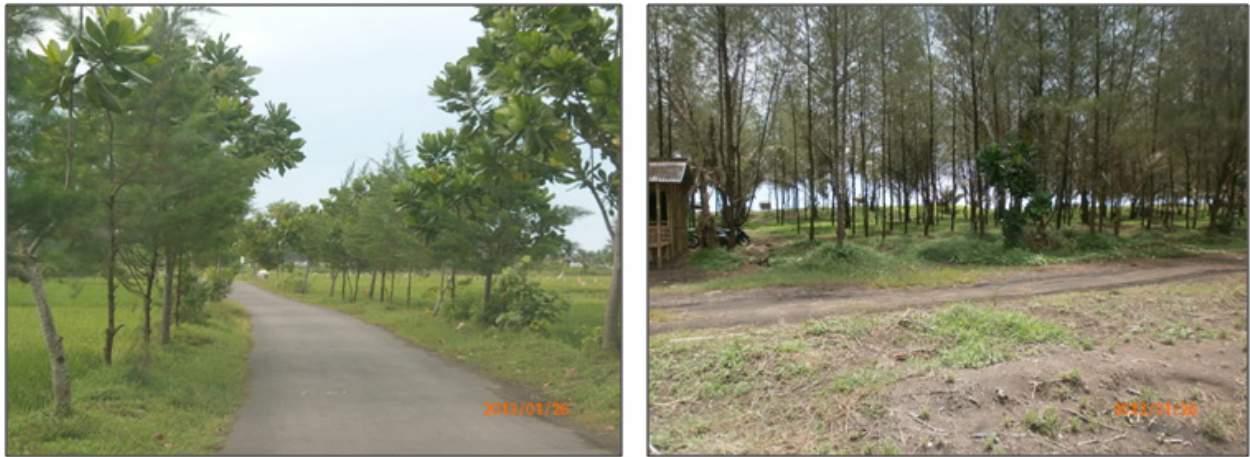
Figure 4. *Casuarina equisetifolia* forest are planted in front of rice field face to the ocean.

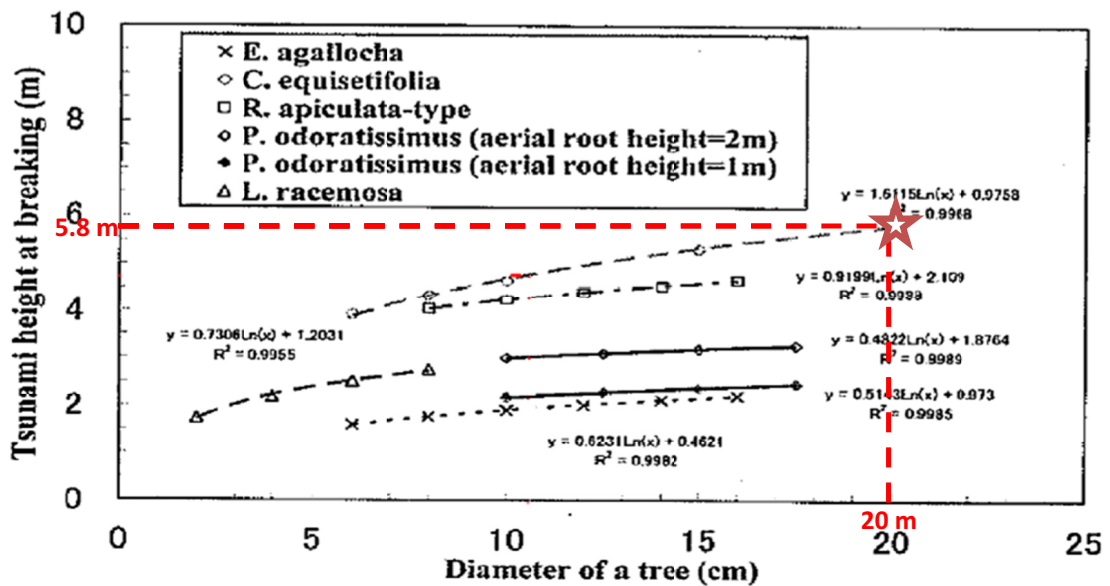
Figure 7. Relation of trees diameter and tsunami height at breaking (Tanaka et.al., 2006)

According to the average tree diameters, Cilacap coastal forest has potential of has broken when tsunami heigh reach 5 m (Figure 7).

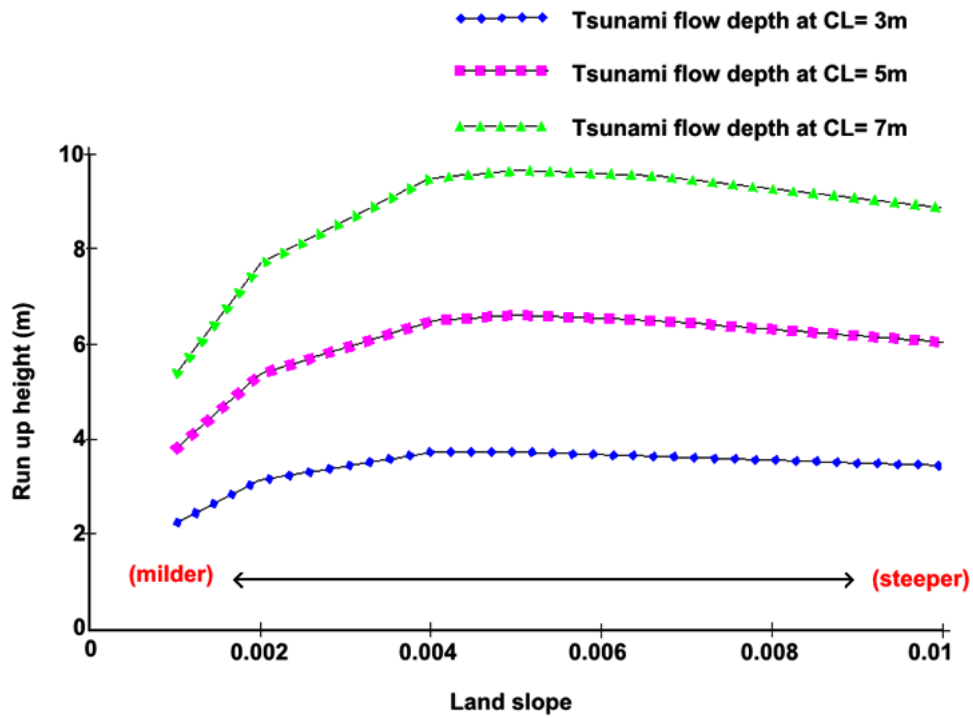
Figure 9. Effect to coastal topography

According to the effect to coastal topography, based on beach profiling measurement (Table 3), Cilacap coasal forest at Selok has land slope steeper

(0.019), but recently dune has potentially removed due to sand mining activity.

Dunes could act as barrier to protect infrastructures behind it, and could dissipate tsunami energy. But it has potentially removed due to mining activity that dig it out to fill in the area after mining.

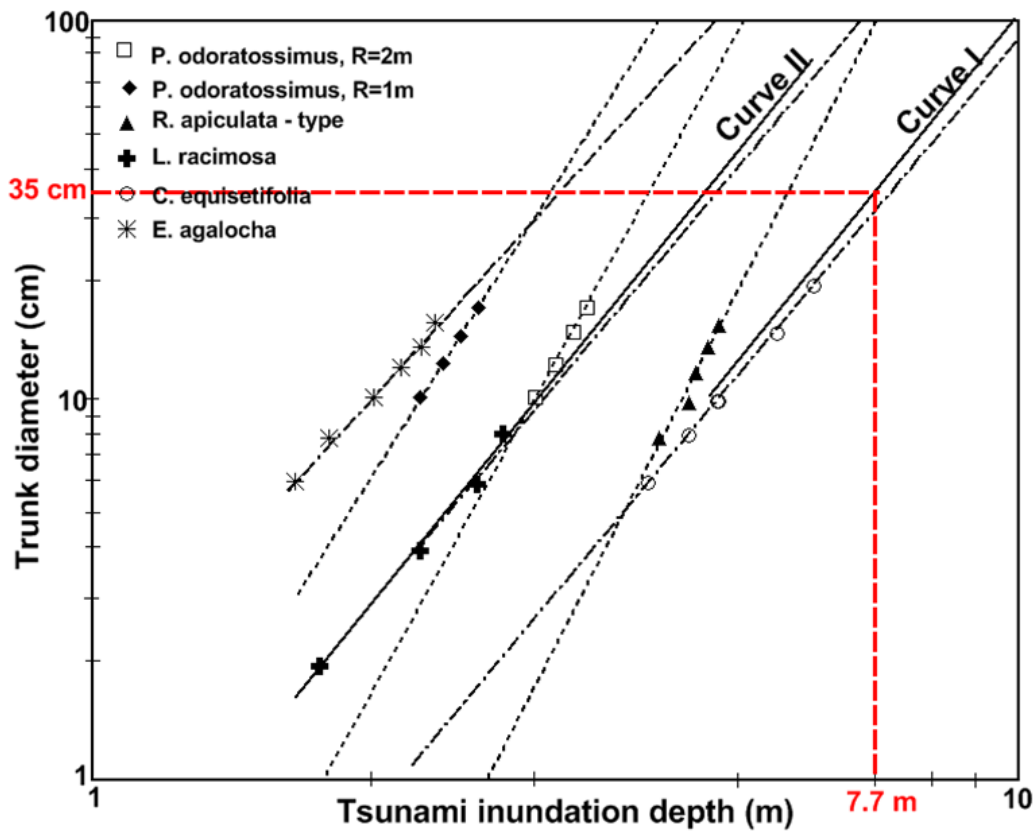
Figure 10. The maximum limit of trees capacity againts tsunami force (Shuto, 1987 and Tanaka et.al., 2006)

According to the maximum limit of trees capacity against tsunami force, *Casuarina equisetifolia* has the maximum breaking capacity ~35 cm of tree diameter, so Cilacap forest has not enough capacity against tsunami forces and need some years to make tree diameters wider, and bigger.

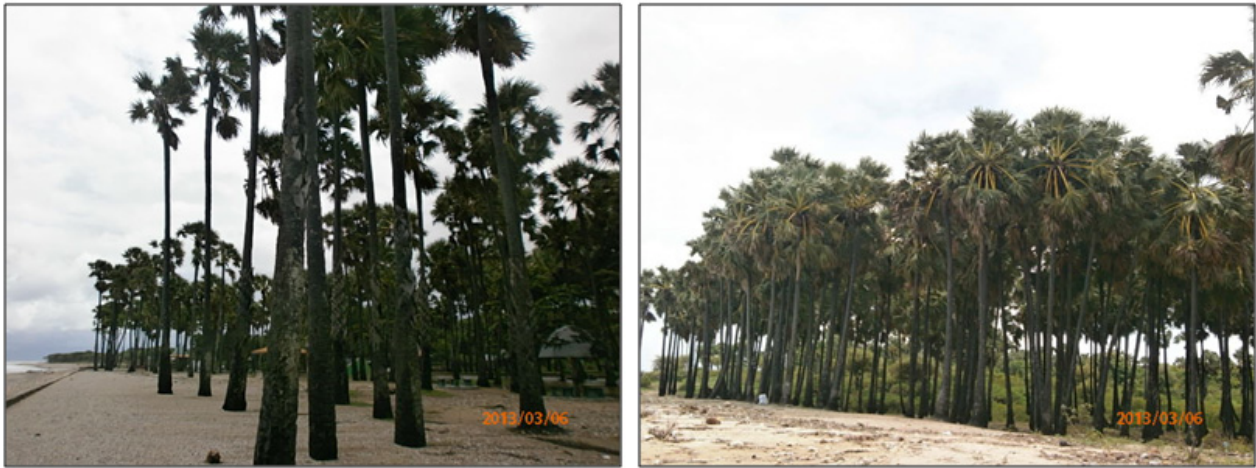
Figure 11. Coastal forest of *Borassus flabellifer* at Lasiana (left) 60-70 years old, and Nunsui (right) has 100 years old (Kurniaprada et.al., 2013).

Borassus flabellifer at Lasiana, Kupang, has 60-70 years old. Forest area is 153.14 ha (38 m width and 403 m length). We made vegetation parameters measurement (Table 4).

By assuming the same tsunami height as in Cilacap (7.7 m), Kupang coastal forest has trees diameter and forest width which could stop floatages and trees will have no damages. Coastal forest of *Borassus flabellifer* has 100 years old at Nunsui, Kupang. Here, forest area is ~200 ha (75 m width and 267 m length), has height 10 – 12.5 m; trunk diameter 37 – 54 cm; spacing of 1.26 – 4 m; number of trees about 400; density of 0.026 m.

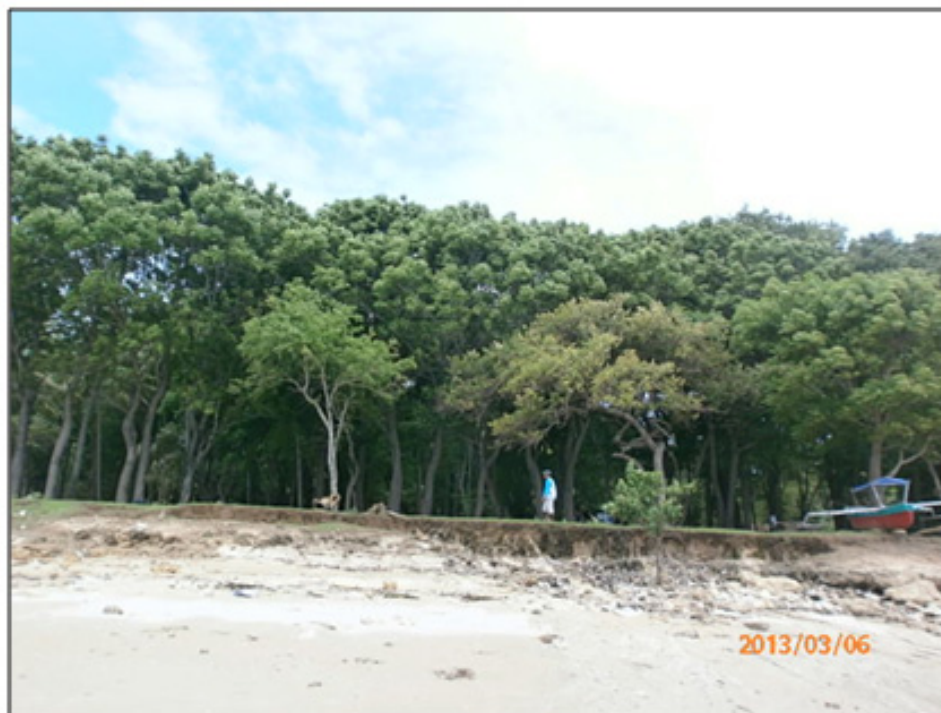
Figure 12. Forest of mixing trees species (Kurniaprja et.al., 2013)

There is a 30 years old coastal forest of mixing trees species (*Tamarindus indica*, *Pithecellobium dulce*, *Ficus benjamina*, *Hibiscus aliaceus*, *Cocos nucifera* and *Canarium caudatum*) (Figure 12).

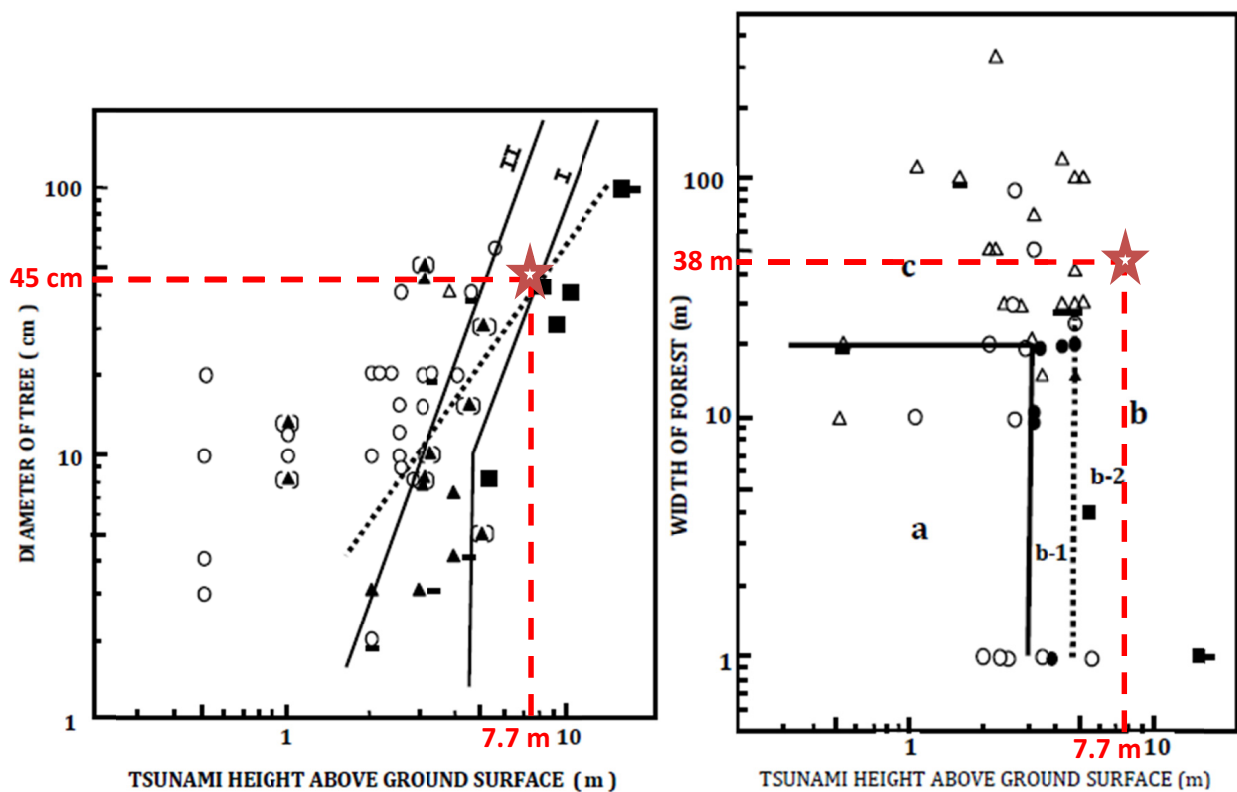
Figure 13. Degree of damage to tree in term of tree diameter (left) and width of forest (right) to the maximum tsunami height.
